PUTTING RESEARCH TO WORK

New Guidelines Take the Guesswork Out of Preparing Surfaces for Overlay

This brief summarizes Project 0092-04-05, “Guidelines for the Surface Preparation/Rehabilitation of Existing Concrete and Asphaltic Pavements Prior to an Asphaltic Concrete Overlay,” produced through the Wisconsin Highway Research Program for the Wisconsin Department of Transportation Research, Development & Technology Transfer Program, 4802 Sheboygan Ave., Madison, WI 53707.

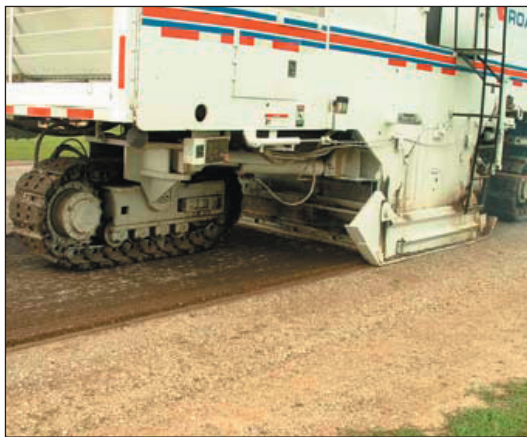
Surface preparation prior to an asphalt overlay may include milling for asphalt pavement (at left; Fig. 4.7, page 48 of final report) and full-depth base patching for concrete (Fig. 4.18, page 56 of final report).

- Pavements with block cracking (interconnected transverse and longitudinal cracks) and surfaces with minor rutting should be milled prior to overlay placement. (During milling, the surface layer is ground off to create an even surface for the overlay.) Major rutting indicates the need for base and subbase investigation.
- When pavements exhibit severe longitudinal cracking, the ratio of overlay thickness to milling depth should be at least 3:1; this will prevent longitudinal cracking from recurring in the overlay.
